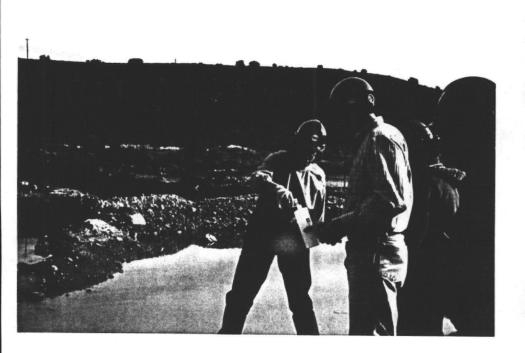
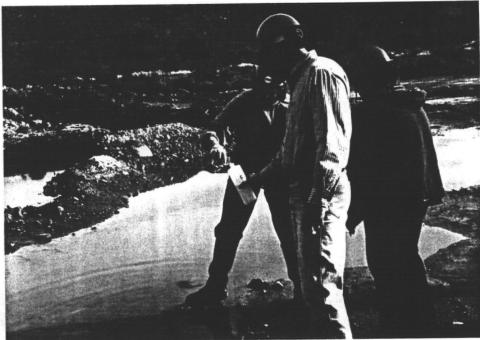
Sediment samples collected from the standing waters adjacent to the collection trench and evaporation pond. Samples were split with the HECLA personnel.
